**ASSABET RIVER BASIN  
ACTON, MASSACHUSETTS**

**ERIKSON DAM  
MA 00195**

# **PHASE I INSPECTION REPORT NATIONAL DAM INSPECTION PROGRAM**

**DECEMBER 1979**

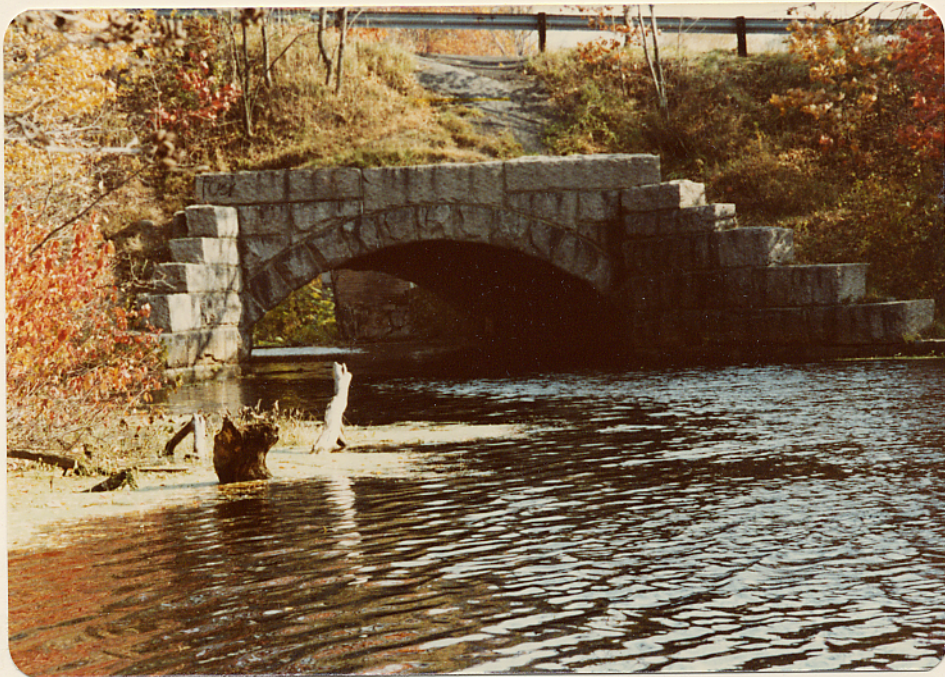
NO. 1 CULVERT UPSTREAM OF DAM

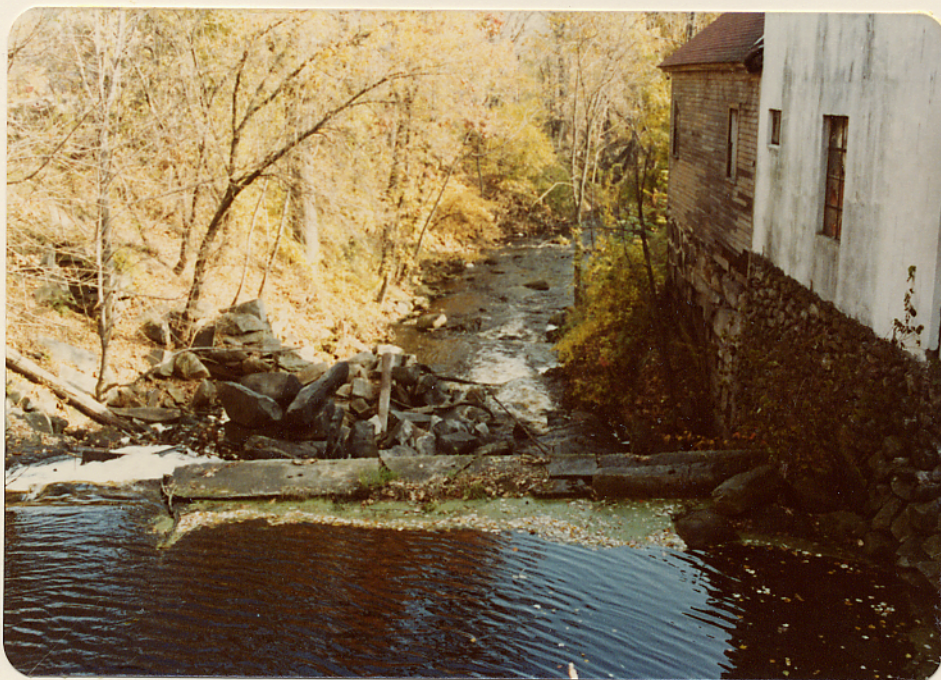
There is a bedrock outcrop visible at the downstream toe of each abutment of the dam. Above the left abutment, however, and along the left bank of the discharge channel, erosion has caused deterioration of the upper slope of the channel. There is no riprap or other protection on the earth slope to prevent further erosion. As a result, several trees are overhanging the channel with their root systems exposed. (See Photographs No. 2 and 8.)

NO. 2 CREST OF SPILLWAY AND DOWNSTREAM CHANNEL

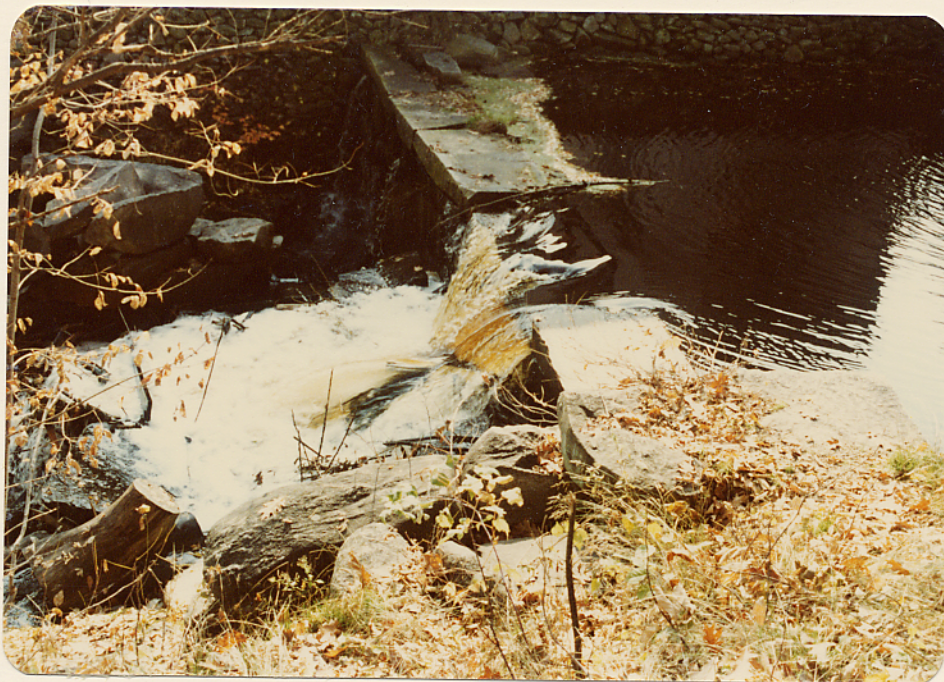
**NO. 3 CREST OF SPILLWAY**

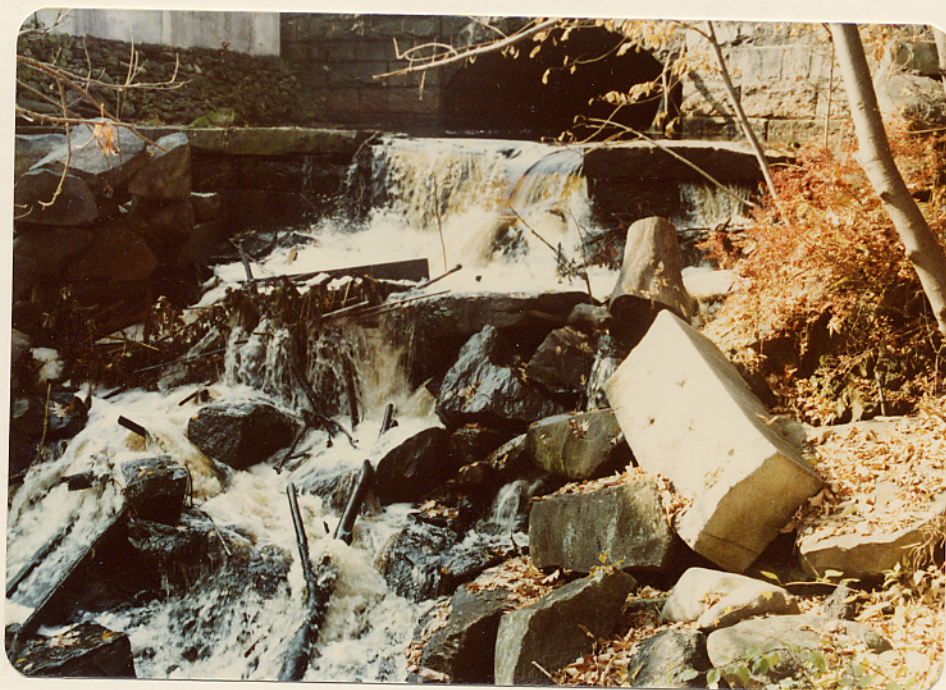
**NO. 4 DEBRIS DOWNSTREAM OF SPILLWAY  
ON NORTH SIDE OF CHANNEL**

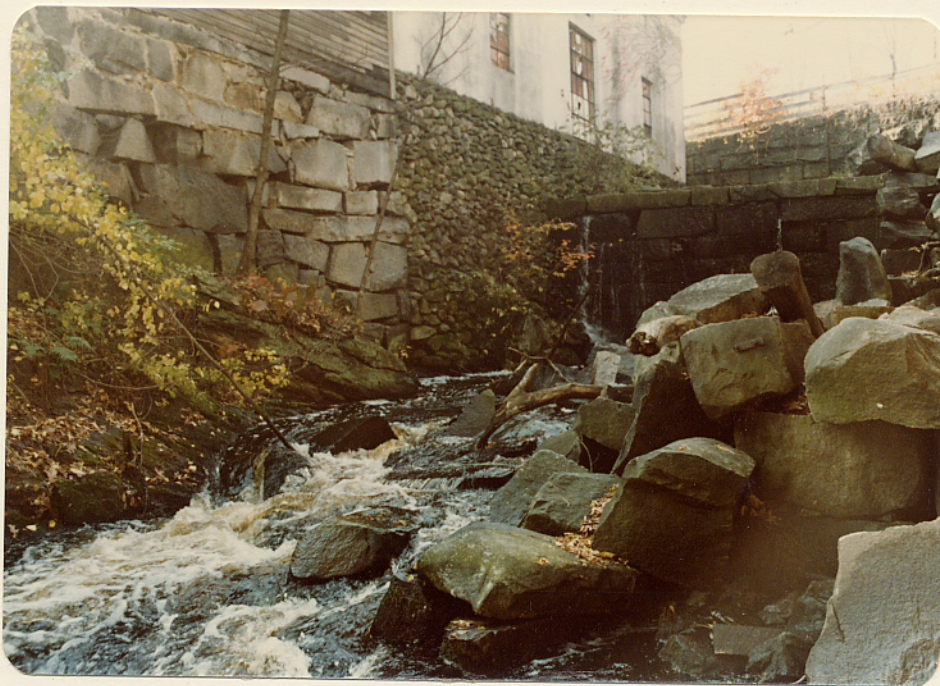
**NO. 5 SOUTH SIDE OF CHANNEL DOWNSTREAM OF SPILLWAY**

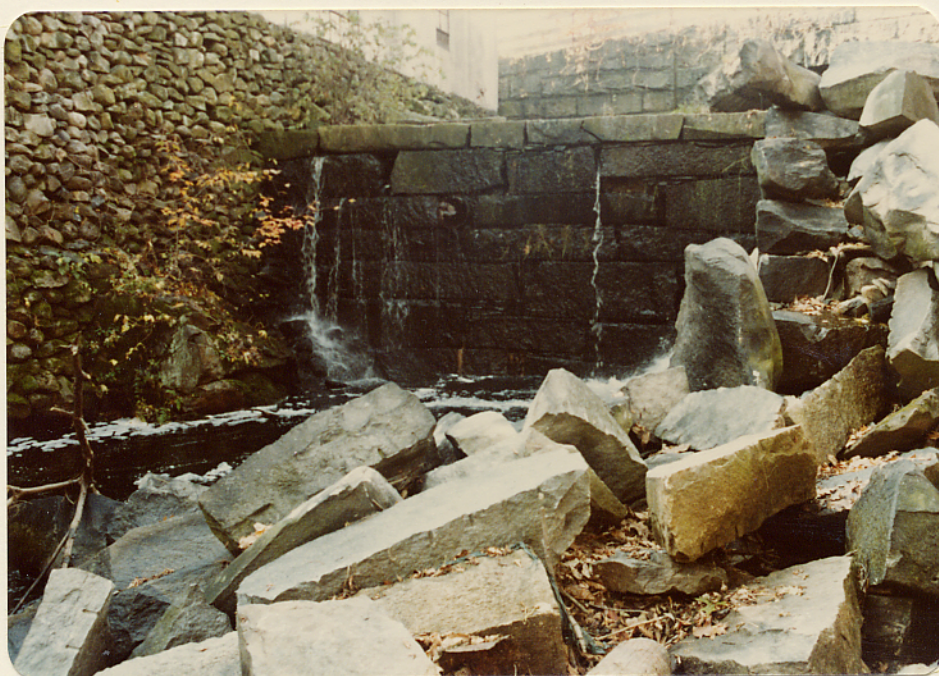
- b. Dam. The dam is generally in poor condition. The most apparent deficiencies in the structure are the lack of a low-level outlet and the large amount of leakage between the unmortared blocks of the dam (see Photograph No. 6). At the time of the inspection, water was flowing over the breached section of the dam and under the granite capstones on the unbreached section (see Photograph No. 3). Significant leakage was also observed at the right abutment of the dam where the stone wall ties into the stone foundation of the remaining mill buildings (see Photographs No. 4 and 8). Two 18-inch diameter pipes were visible in the downstream face of the dam. No flow was observed from either, and the lower pipe appears to be crushed at the outlet end. There is no valve or control structure for the pipes and it is likely that both pipes were either blocked or have silted up over the years.

The rubble remains of the abandoned sawmill building fill the channel downstream of the breached section of the dam (see Photographs No. 6 and 8). Previous inspection reports have suggested that the stones may increase the stability of the dam and should be left in place. There is, however, a wall of rock that is apparently free-standing in the middle of the channel. Besides causing an obstruction to flow over the dam, the wall represents a hazard in that it may collapse at any time.

**NO. 6 DOWNSTREAM FACE OF SPILLWAY — ABANDONED  
STONE FOUNDATION OF MILL BUILDING**

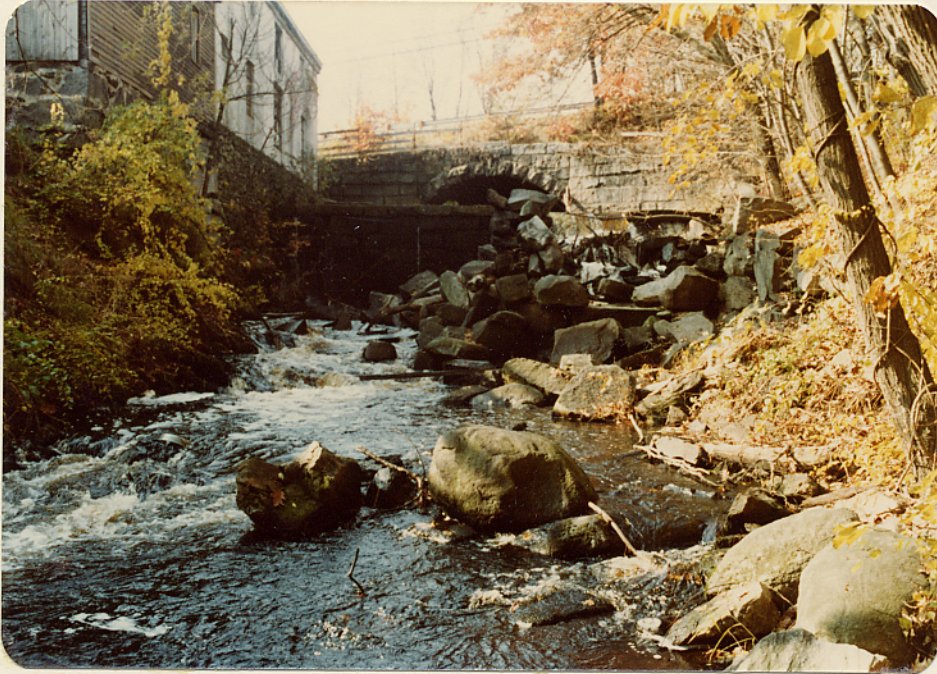
**NO. 7 DOWNSTREAM CHANNEL AND UPSTREAM CULVERT**

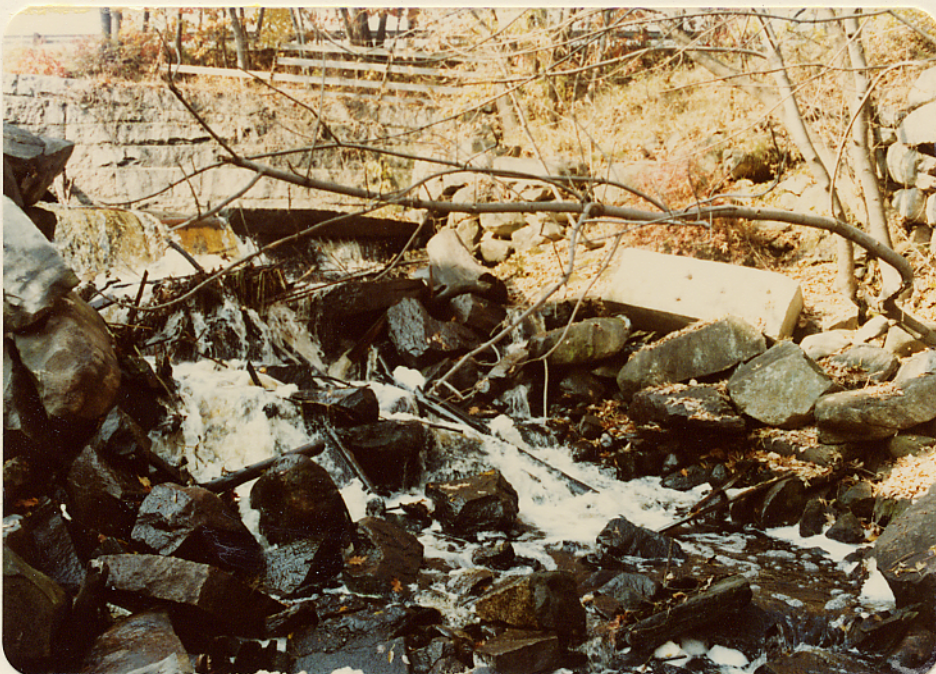
**NO. 8 NORTH ABUTMENT OF DAM AND ABANDONED  
STONE FOUNDATION OF MILL BUILDING**
